**WaQuAC-NET Newsletter vol.30 CONTENTS**

**Kumamoto earthquake Report**

*- Impact of earthquake with seismic intensity 7, and 2 barrage -*

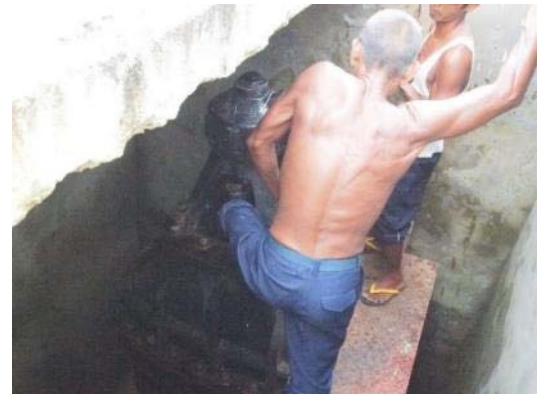
*At a valve near a pumping station. It takes 45 minutes to open/close a valve manually.*

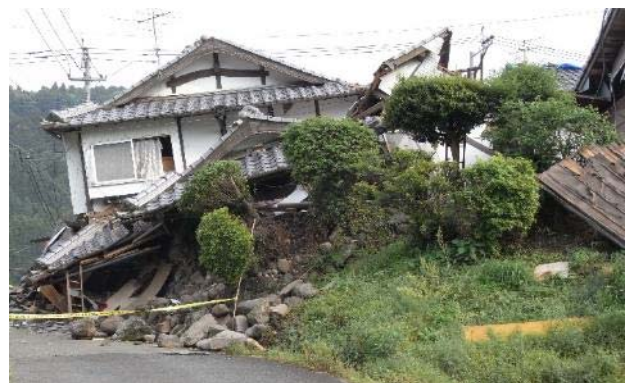
*Collapsed buildings show how hard the earthquakes was (Oyatsu District, Mashiki Town)*

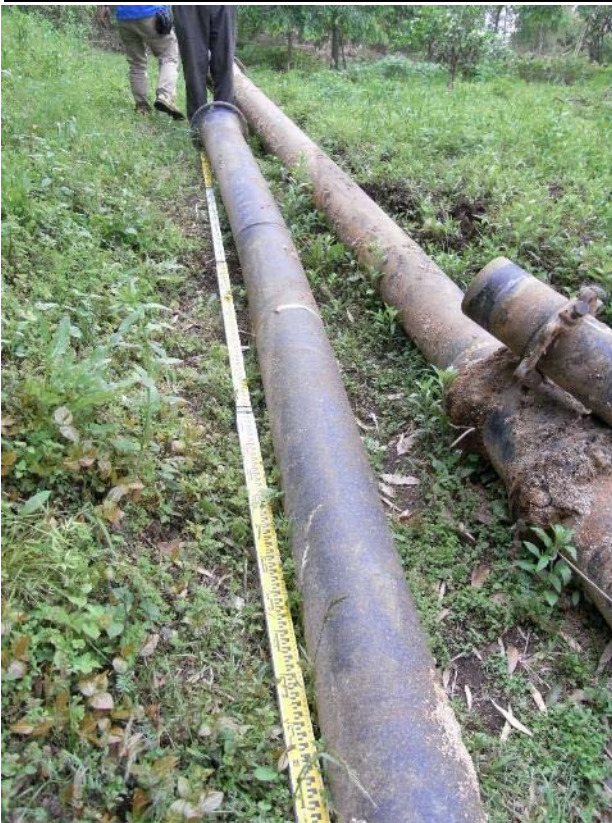
*Damaged DIP of D200, and D150 (K type)  
(Mashiki Town, Fukuda District)  
Distortion of the pipe shows how large stress  
put on the pipe*

Disjointing of not only A-type mechanical joint but also K-type mechanical joint were found in the affected areas. It is inevitable to disjoin when the applied force to a pipe exceeds a design value. Even under such a situation, DIP itself was not damaged at all, which can prove toughness of the DIP. Jointing of earthquake resistance DIP bend

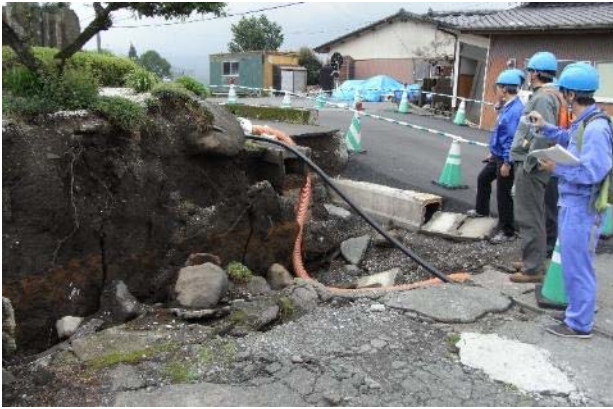
### **Surface faulting appeared in Kario District, Aso City**

We can see how largely active fault moved in Kario District, Aso City. It locates more than 42 km far to the east-northeast from the center of Kumamoto. There is the fault of 40 ~ 50m wide and 1 km long crossing Prefectural Road No. 175. This fault

supplied to the residents by temporarily installed PE pipe.

Faulting crossed a farmland, and came to Kaibara Bridge over the Otohime River, where a distribution iron pipe of D 80mm hang to the bridge disjoined which disjoined a distribution iron pipe of D 80mm hang to the bridge.

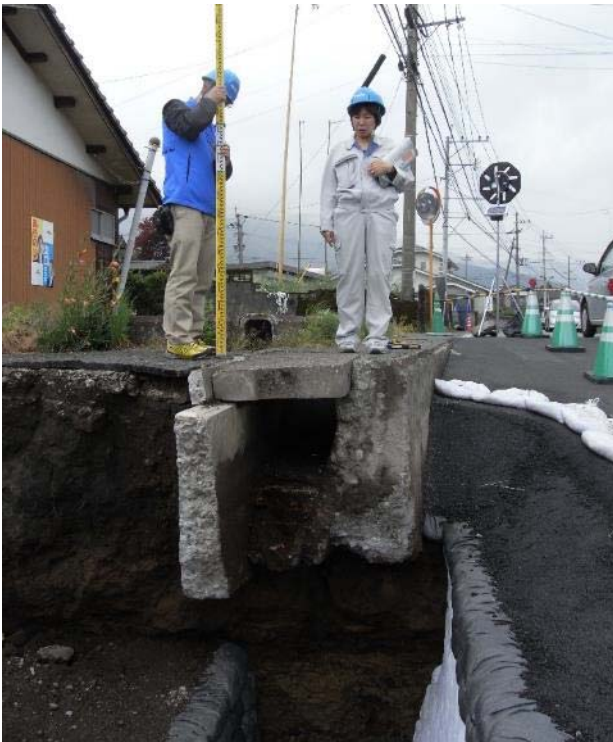
*(Upper and lower) Surface faulting appeared in Kario District, Aso City. Faulting was 40~50 m wide, 1.6~2.1 m of displacement height, and 1 km long in total.*

became well-known at an early stage from the earthquake by "tweet" on Twitter, pictures posted on the Web. On May 7 when I visited there, the faulting had become a paved slope with asphalt in order to ensure the passage. According to the posted pictures on the web taken immediately after the quake, the road looked like to be scraped off by a giant ax, and a ladder was subjected. Depression height was 1.6 ~ 2.1m. A house facing the prefectural road in remained as it was at the time of the quake occurrence; part of the building had been up float in the air. And PVC pipe was laid in this area, and of course, disjoined. Water is

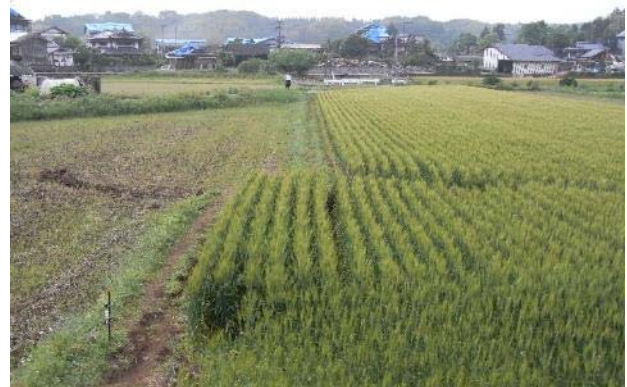
*Horizontal faults appeared in Mashiki Town. 2 m of horizontal displacement clearly remains.*

In the affected areas of Mashiki, it is too horrible to look at collapsed houses as far as the eye can reach. I saw the horizontal faults of 2m in the Mashiki. A line, looking like digging by something, crosses the paved road from a cliff of a hill to a bank, and the wheat field, continuing all the way to the far. Wheat field looks as if they were mowed to arrange the strip. It was the site of the strike-slip. Though a horizontal fault cannot be clearly seen at the ground or roads, it appears at wheat field with its strike-slip clearly. And, a great number of houses collapsed at a distance.

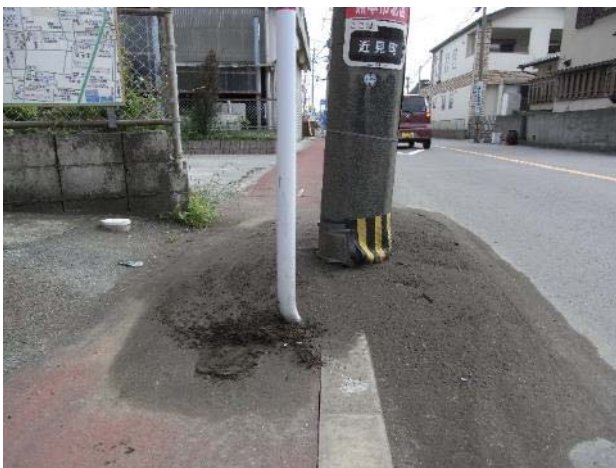
*Situation of liquefaction in eastern Kumamoto City. The sign on the utility pole shows displacement depth.*

I made a survey in Minami-ku, Kumamoto. Even though 3 weeks has passed since the earthquake, I could see still traces of jetted sand here and there. Unlike the area where the buildings collapsed in intense ground motion, the damage of this area seems not to be too severe at a glance. However, there are tilted houses, and it will be difficult how to restore the tilted house. Due to the liquefaction, houses and utility poles are tilted not to the same

direction, but to the pulled direction respectively by liquefaction. There is a telephone pole which has sunk vertically almost 80cm depth.

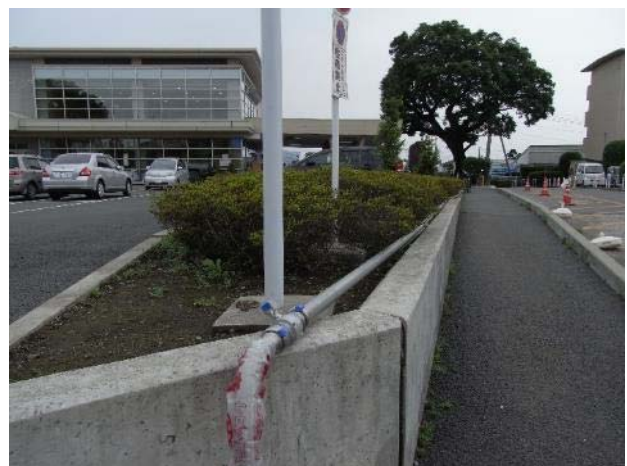
*Temporal water service pipe supplying to the Mashiki Health and Welfare Center, temporarily used for an evacuation shelter.*
