# The Investigation Team Report on the Damages of Water Supply Utility by the Great East Japan Earthquake 2011

(Provisional translation)

\* This is provisional and abridged translation of “the Report” published by Water Supply Division, Health Service Bureau, Ministry of Health, Labour and Welfare (MHLW) and Japan Water Works Association (JWWA) in September 2011. English translation is carried out by WaQuAC-NET and there is no concern of MHLW and JWWA. WaQuAc-NET is fully responsible for the any problems of English description. Please refer to the original report written in Japanese.

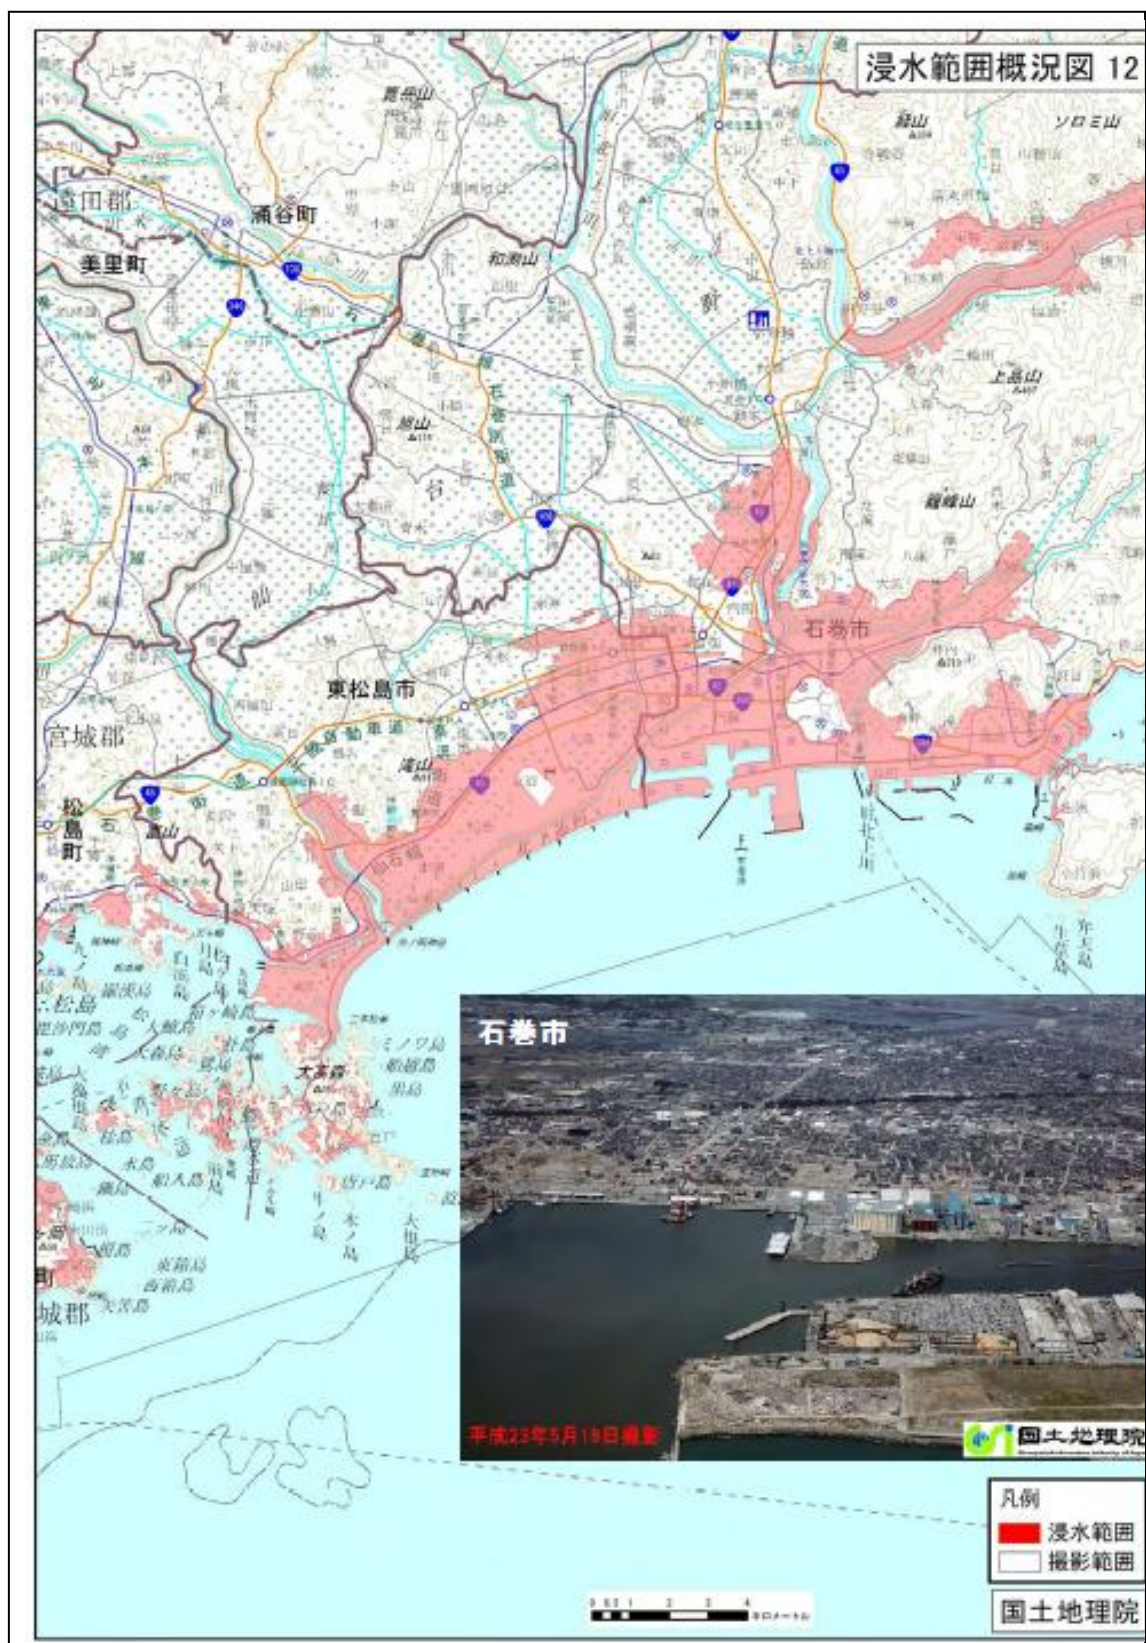
Fig.3 Flooded area in **Ishinomaki City**  
(highlighted in pinkish color)

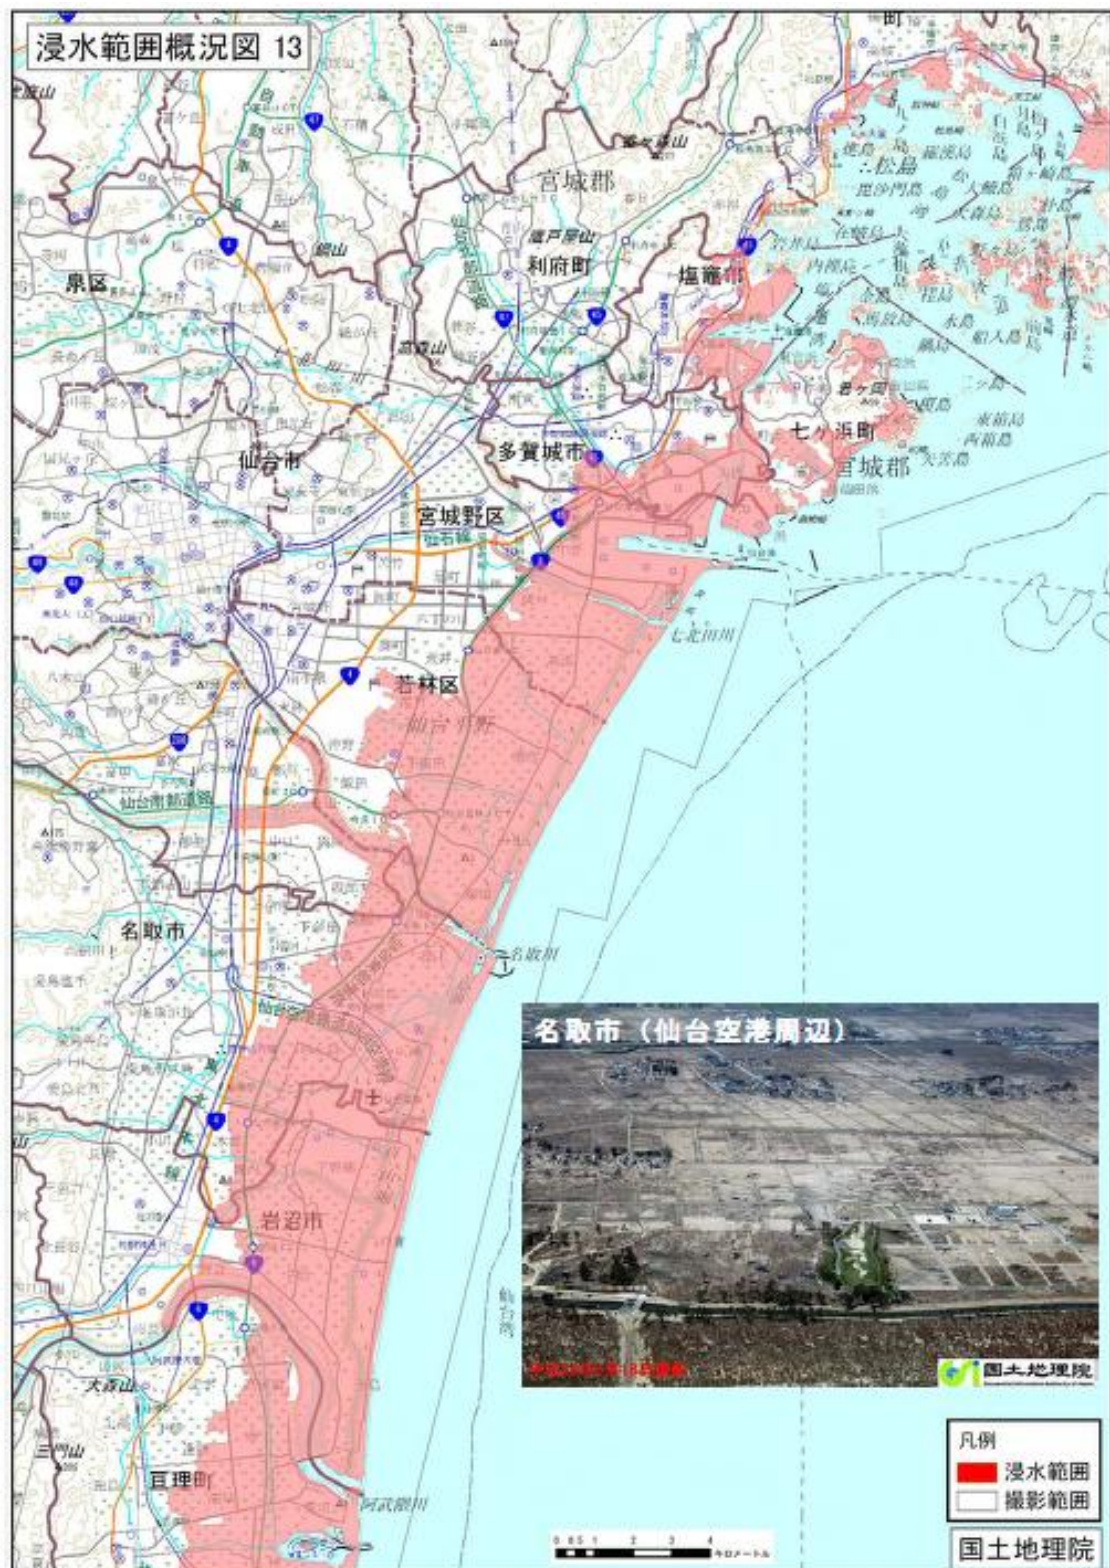
Fig. 4 Flooded area in **Sendai**
